Manhole Inspection Summary

Manhole # S29A__104MH

Insp Date: **4/29/09 3:36 PM**

Location Address: **636 PERKINS ST**

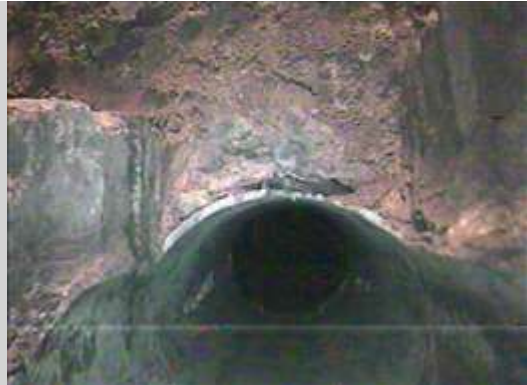
12 O'Clock Outflow

8 in. Circular Gravity Sewer
Pipe Out @ 12 O'Clock

Pipe Height: (in.) Direct
Pipe Material: **PVC** ☐ Pipe Lined
Invert Depth: **12.20** (ft.) Flow Characteristics: **Slow**
Deposits: ☒ None ☐ Mud ☐ Sludge ☐ Debris ☐ Grease
Silt Depth: (in.) Deposits Extent:
Infiltration: **None** Pipe Seal Cond: **Sound**

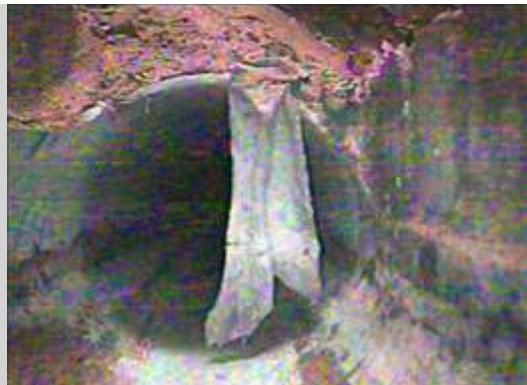
6 O'Clock Inflow

8 in. Circular Gravity Sewer
Pipe In @ 6 O'Clock

Pipe Height: (in.) Direct
Pipe Material: **PVC** ☐ Pipe Lined
Invert Depth: **12.00** (ft.) Flow Characteristics: **Slow**
Deposits: ☒ None ☐ Mud ☐ Sludge ☐ Debris ☐ Grease
Silt Depth: (in.) Deposits Extent:
Infiltration: **None** Pipe Seal Cond: **Sound**

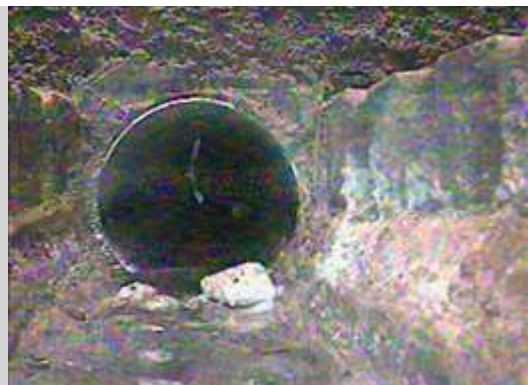
9 O'Clock Inflow

8 in. Circular Gravity Sewer

Pipe In @ 9 O'Clock

Pipe Material: **Clay** ☐ Pipe Lined

Invert Depth: **11.98** (ft.) Flow Characteristics: **Slow**

Infiltration: **None** Pipe Seal Cond: **Sound**
